Science and Engineering Symposium
4th International Science, Social Science, Engineering and Energy Conference 2012

A Case Study on Housing Estate Damages Due to 2011 Thailand Flood at Casa Ville Watcharapol

V. Panichacarn^{a,*}

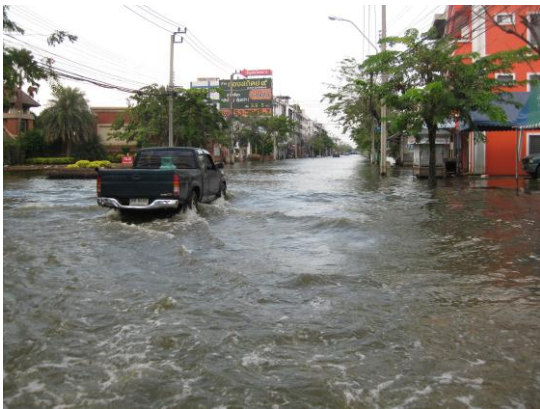
Fig. 1. Water level in front of the village (Nov.24th, 2011)

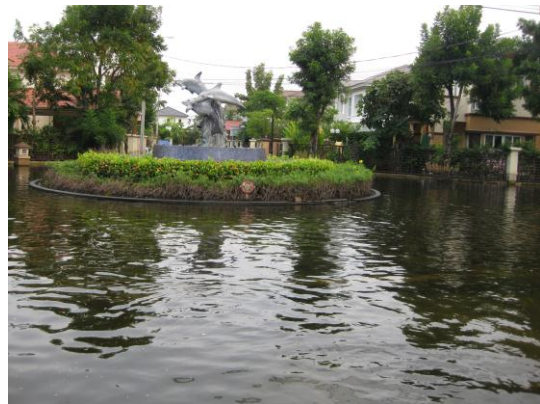
Fig. 2. Water level in the village public area (Nov.24th, 2011)

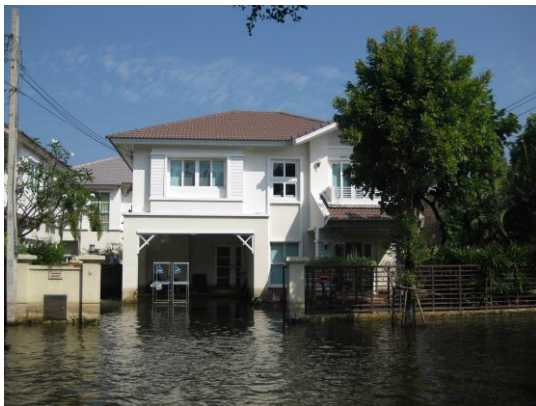
Fig. 3. Water level outside a house (Nov.25th, 2011)

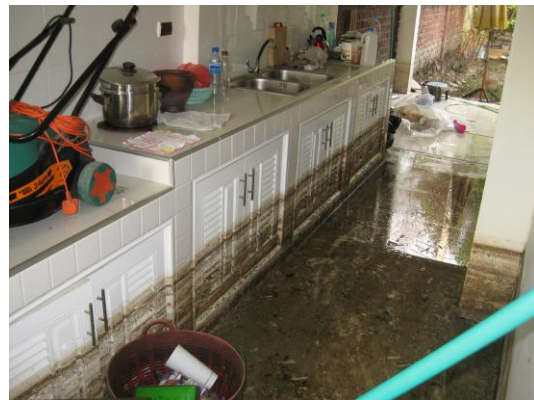
Fig. 4. Water level inside a house (Nov.26th, 2011)

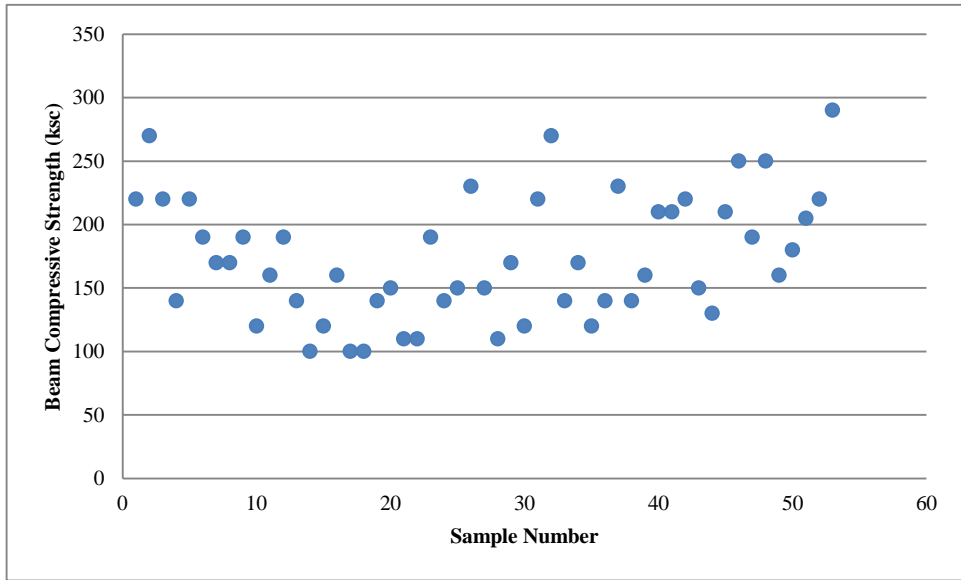
The survey was carried out in July 2012. All 397 houses in Casa Ville Watcharapol village were checked for the study. Since the characteristic of this village is living privately and quietly, 59 house owners allowed the researcher to conduct the survey. However, even though the Schmidt Hammer test did not destroy any beams or columns, 6 owners refused the test because they just had new paint on the house. For each house, 15 numbers of first floor beam strength reading were averaged and that numbers are shown in Fig 6. The first floor column strength readings of each house were also averaged and are plotted in Fig 7. Finally, these numbers were again averaged for the whole village. The average first floor beam and column compressive strengths are 173.87 and 171.98 ksc, respectively.

Fig. 6. First floor beam compressive strength reading from 53 samples

By comparing the testing beam/column strengths at around 170 ksc with the estimated original strength at 160-180 ksc, the first floor concrete beam and column still have high strength after the flood. Hence, it can be concluded that the structural members of the house in Casa Ville Watcharapol village, in general, are strong and safe. However, only a few houses had the strength less than 130 ksc which is considerably low. The researcher also found moisture left in the concrete in these houses as well. It is possible that there might be an underground water line passing underneath the house. In this case, the house owners were suggested to contact an engineer for a further detail inspection.

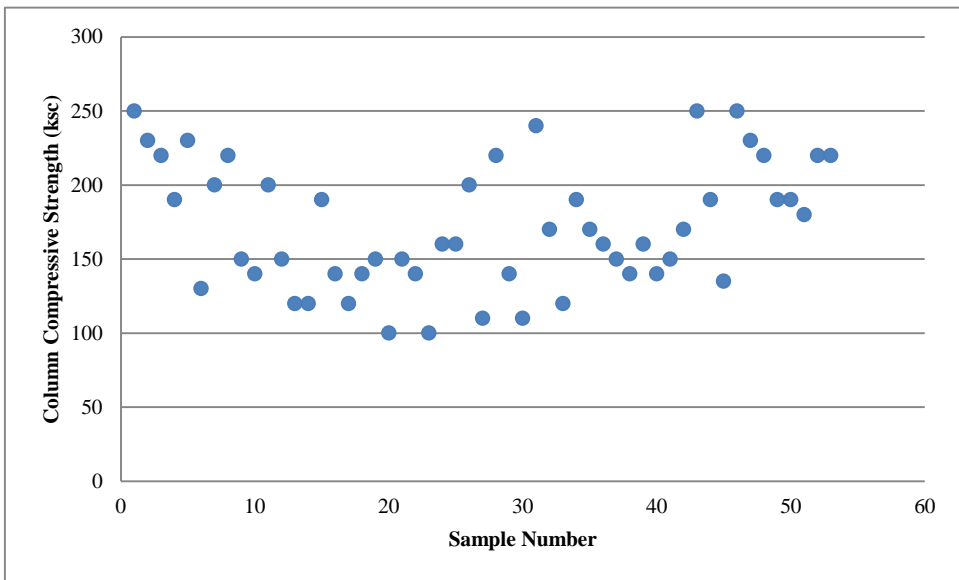
Fig. 7. First floor column compressive strength reading from 53 samples
